# Turnstile

## FAQ Manual

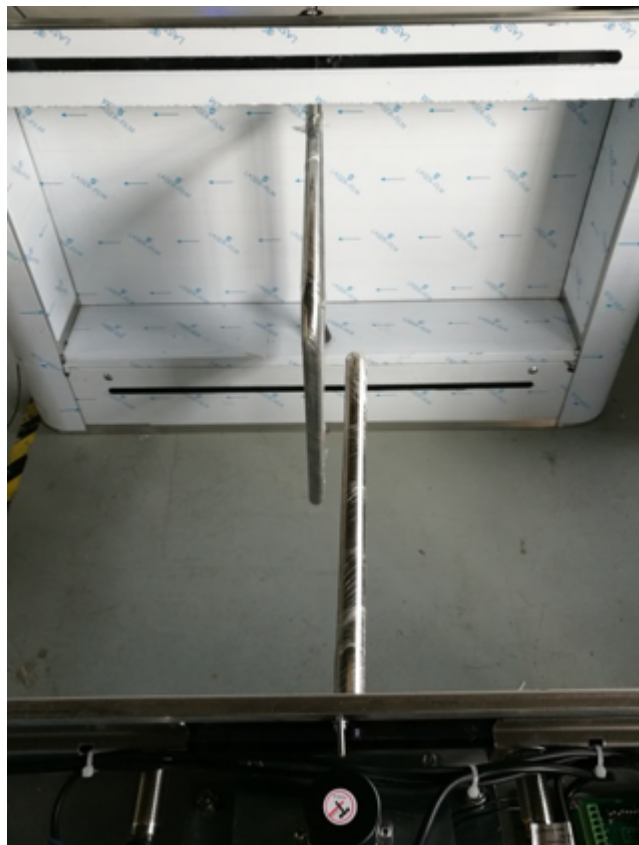
Figure 4-1 Unaligned arms

The swing arms of the swing barrier do not align.

- The cases do not align.
- The original points are incorrectly set.
- The control board is damaged.

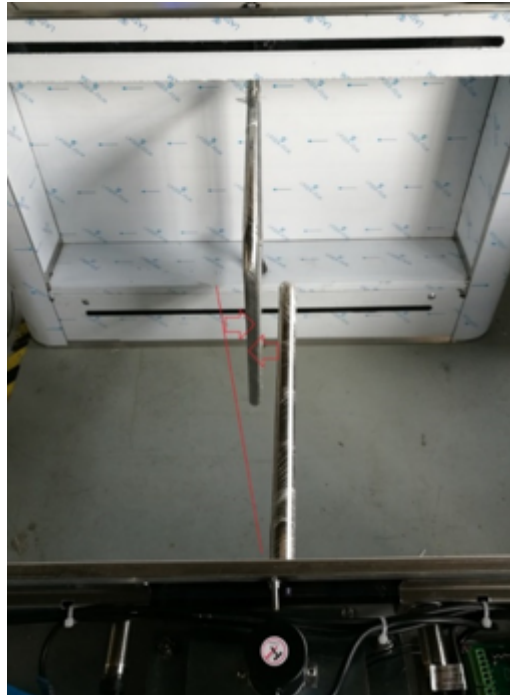
Figure 4-2 Unaligned arms

The swing arms cannot be aligned due to the impact of external forces. The swing arm can be manually pushed in the following range without any resistance, and the swing arm swings left and right when closing the door.

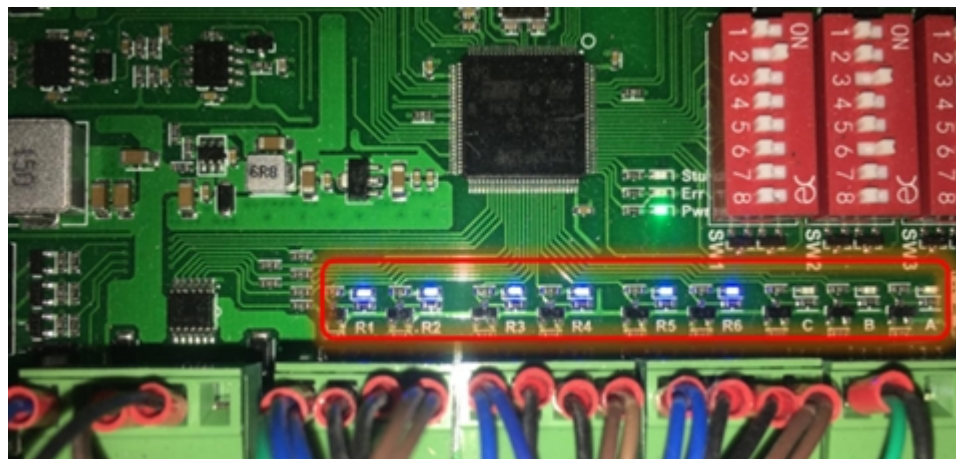
Figure 4-13 IR sensor indicator

If the IR sensor is blocked or unaligned, the indicator is shown as follows. After it is aligned, the indicator will be off.

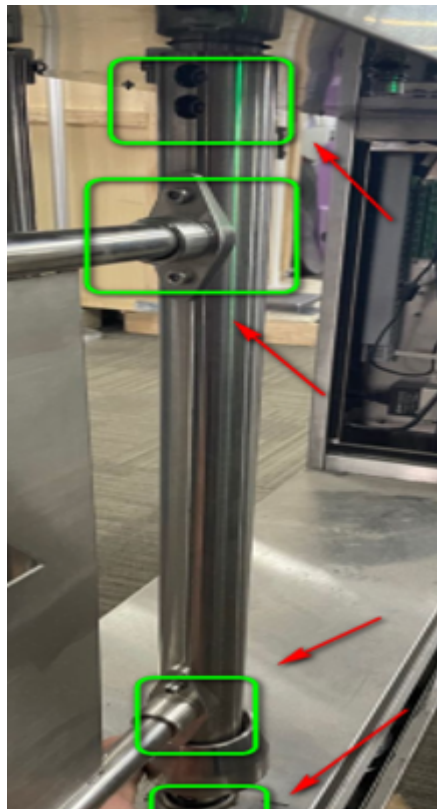
Figure 4-16 Arms screws (1)

1. Calibrate the zero-position.
  - a. Enter the menu of the fault Turnstile motherboard.
  - b. Select **Start Mode** > **Origin setting**, and then press **OK**.
  - c. Power off the Turnstile, align the arms, and then power on.
  - d. After the Turnstile's self-test, enter the motherboard menu again, and then select **Start Mode** > **Normal**, and then press **OK**.
2. If the zero position does not take effect, check the arms screws.

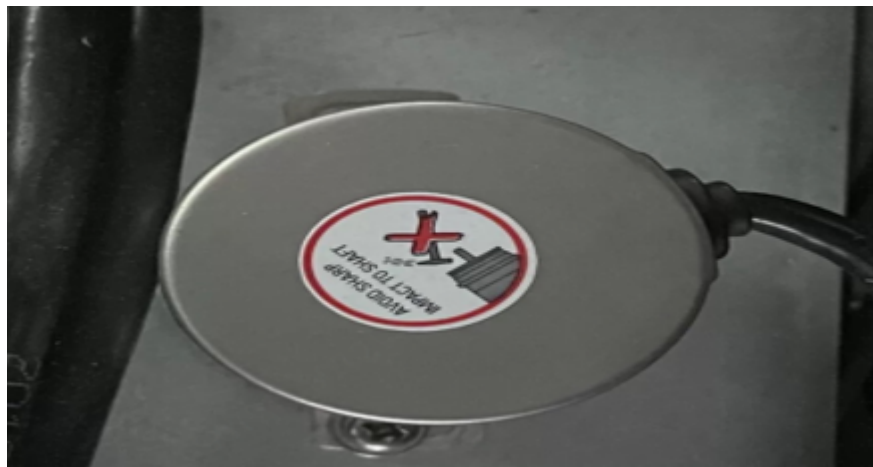
Figure 4-19 Encoder (1)

- b. Check whether the connecting shaft screws of encoder is loose (the connecting shaft is a small socket head cap screw and needs to be glued, please check carefully).

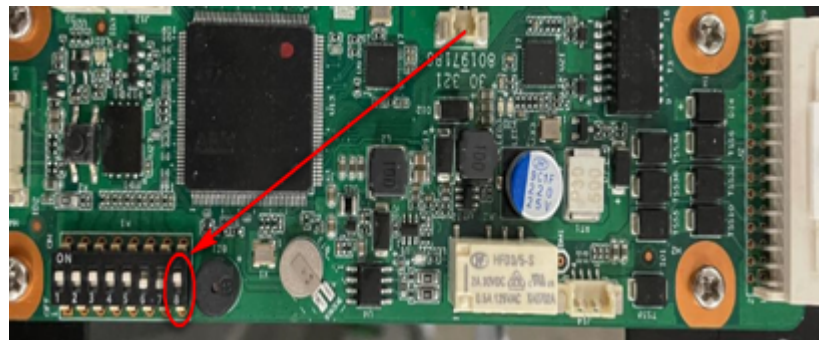
Figure 4-22 Access controller

1. In the local menu of the face recognition device, select **Communication** > **Serial Port** > **Serial Port Input**, and then select **Door 1**.
2. Make sure that the card used is an IC card, and try other cards several times.
3. Contact technical support to obtain the upper computer software.
4. Add access controller to the upper computer software.
  - ◇ Default IP: 192.168.1.108.
  - ◇ Account: admin.
  - ◇ Password: admin.
5. Check the version number of the access controller, and contact technical support to check whether the version and card type are consistent.
- Add the face recognition device to the SmartPSS Lite, and there is no card number to be reported after swiping the card (the access controller and the face recognition device are connected through 485 communication).
  1. Set the DIP switch of the access controller to ON.
